Application of ultrasonic tomography to characterize the mechanical state of standing trees (*Picea abies*)

L Brancheriau¹, A Ghodrati², P Gallet¹, P Thaunay¹, P Lasaygues³

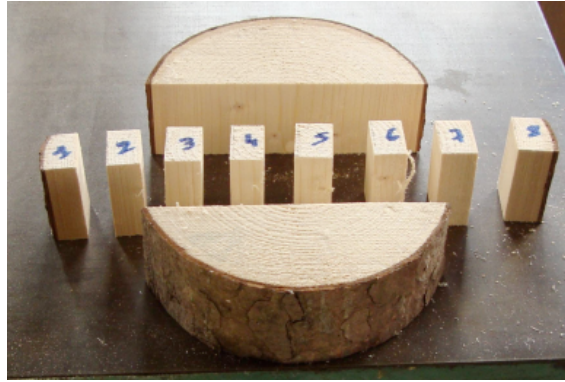
Figure 1. Sampling pattern for moisture content determination (dimensions of the small samples: 2x3x5 cm³).

The first log was cut in two disks of 5 cm thick and one disk of 15 cm thick. These disks were sampled in the middle area of the log to avoid cracks due to wood drying and to have high moisture content. The disks of 5 cm thick were used to determine the mean moisture content and also the moisture content profile along the radius (Figure 1). The moisture content was determined before and after the ultrasonic tests. The samples of Figure 1 were weighted then dried in an oven (103°C) during 48 hours then weighted again. The Equation 1 was used to compute the moisture content.

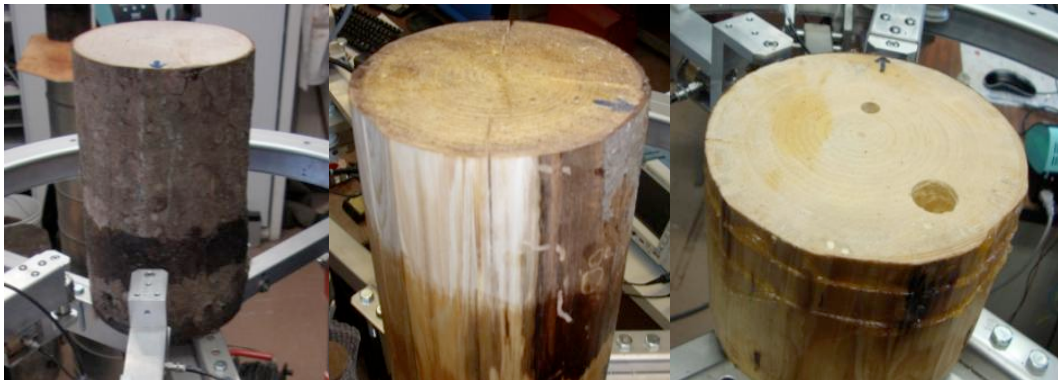
Figure 2. Tomography tests on the first log (from left to right: bark, debarked and drilled with two holes of diameter 1 cm and 2 cm).

The disk of 15 cm thick was tested in tomography with 3 states of the sample: bark, debarked and drilled (2 holes of diameter 1 cm and 2 cm, see Figure 2). The tomography tests were made with two repetitions and an angular step of 30° to estimate the measurement uncertainties and with an angular step of 10° for tomographic imaging.

The mean moisture content was 23% before the tests and 21% at the end of the experiment. The moisture content profile along the radius was presented at the Figure 7. The difference in moisture content from the pith to the bark was 5% before test and 10% after test. Despite the presence of the plastic film on the logs and on the disks, the wood samples tested were not in a green state and the natural drying effect increased while testing (phenomenon important after debarking). Small cracks appeared at the periphery of the disks due to drying (Figure 2, right image).

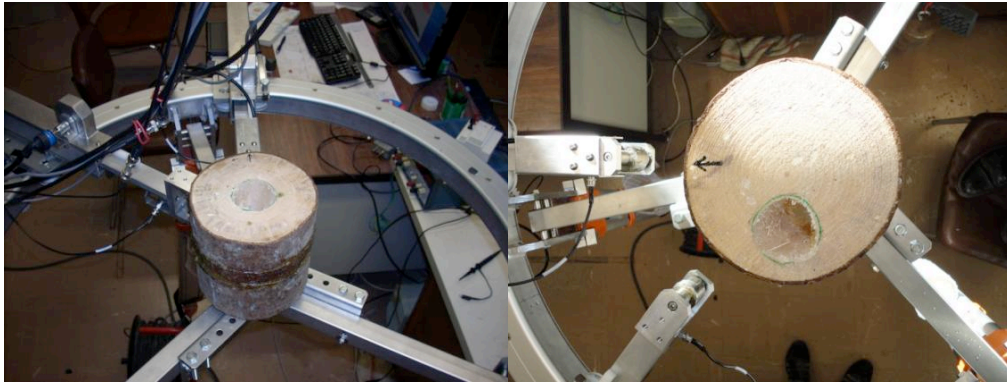
Figure 3. Tomography tests on the two disks of the second log (hole diameter of 5 cm).

The second log was cut in two disks of thickness 15 cm. These disks were sampled in the middle area of the log. In each disk a hole of diameter 5 cm was drilled, one in the middle and the second off-centered (Figure 3). These two disks were tested in tomography with an angular step of 10°.

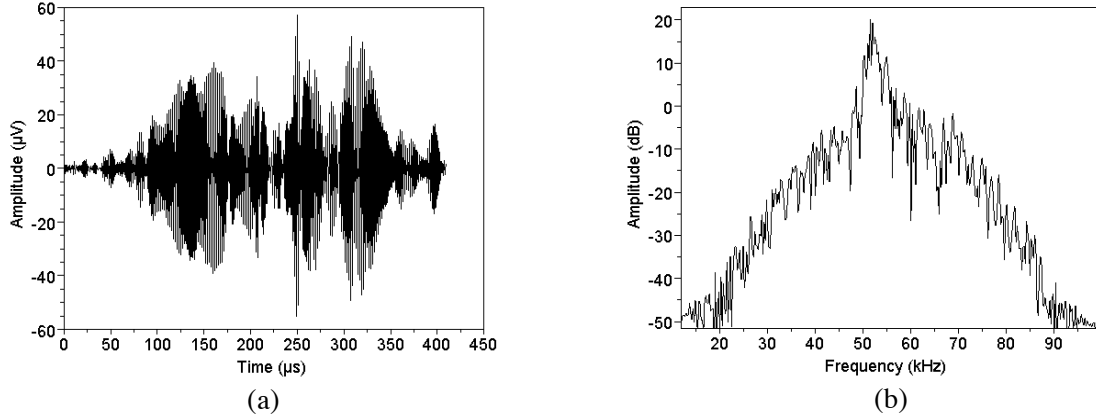
Figure 5. Ultrasonic signal filtered by a Morlet wavelet at 55 kHz with a bandwidth of 20 kHz (a) and associated Fourier transform (b).

The probes had a frequency of 55 kHz and were designed for acoustic emission purpose. These probes were mounted on a specific support with a wheel and grease was used as coupling medium. The emission consisted in 5 square periods of 480 V. The output analog signal was amplified of 80 dB. The acquisition was performed by a converter of 16 bits resolution and a sampling frequency of 5

MHz. The duration of acquisition was set to 410 μ s. The output signal was previously filtered by a Morlet wavelet at 55 kHz with a bandwidth of 20 kHz for denoising (Figure 5).

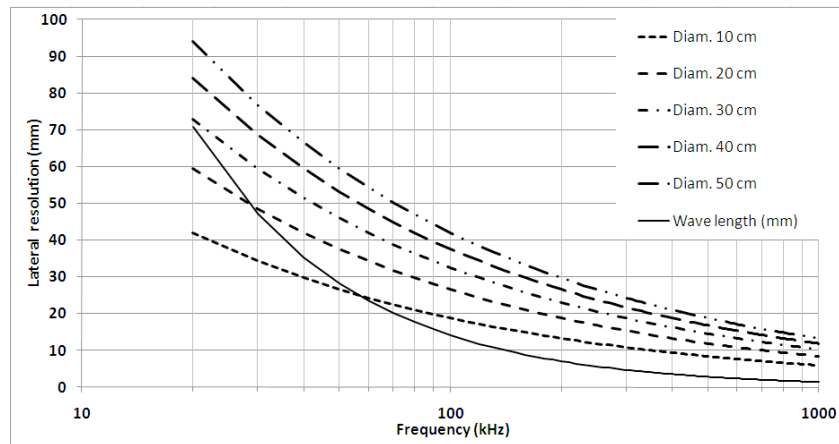
Figure 6. Lateral resolution and wavelength as a function of the frequency and according to the sample diameter (the acoustic wave speed was set to 1400 m/s).

The theoretical upper limit of the number of computed pixels was 450 (mesh of 39 mm², Equation 4). The physical resolution was however about 26 mm (axial resolution: wavelength) and 31 mm (lateral resolution: Fresnel zone, Equation 5, Figure 6). This resolution led to a mesh of 806 mm²; the images were thus 2D smoothed by a blackman filter of the wavelength size (the errors induced by the use of the modified Shepp-Logan filter was also highly reduced). It was important to highlight that the redundancy of the information (39 mm² compared to 806 mm²) allowed to decrease the effect of erroneous experimental values in the imaging process.

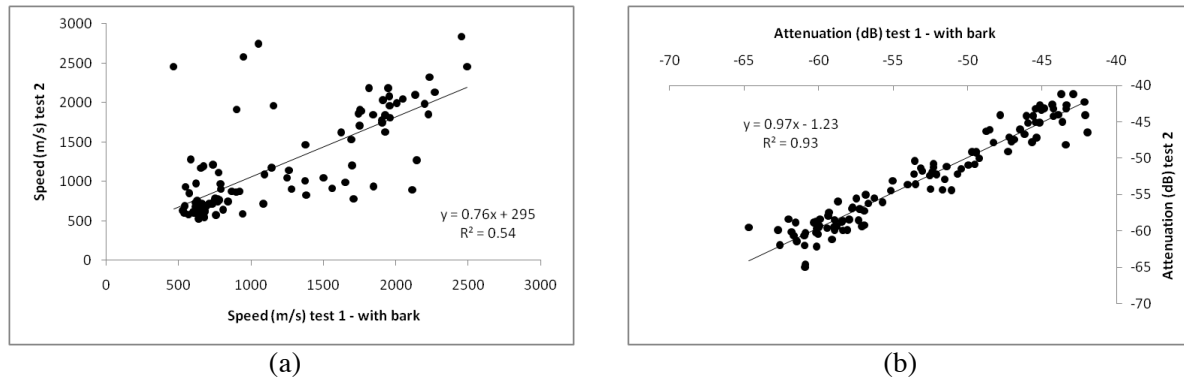
Figure 8. Relationship between the two repetitions for (a) speed and (b) attenuation (disk with bark, $N=108$).

Two tomography tests were made with an angular step of 30° (108 acquisitions) on the same disk (with bark, debarked and drilled). The results were shown at the Figure 8 only for the disk with bark because the trends were very similar after debarking and drilling. Significant linear relationships were found for the speed ($R^2 = 0.54$, $F = 105$, $p < 0.001$, $N = 108$) and for the attenuation ($R^2 = 0.93$, $F = 1373$, $p < 0.001$, $N = 108$). The presence of outliers in the scatter plots of speed (Figure 8, a) was caused by errors in the travel time estimation. The standard error of the speed determination was thus ± 420 m/s. The attenuation had a low measurement error compared to the speed estimation with a standard error equal to ± 1.7 dB.

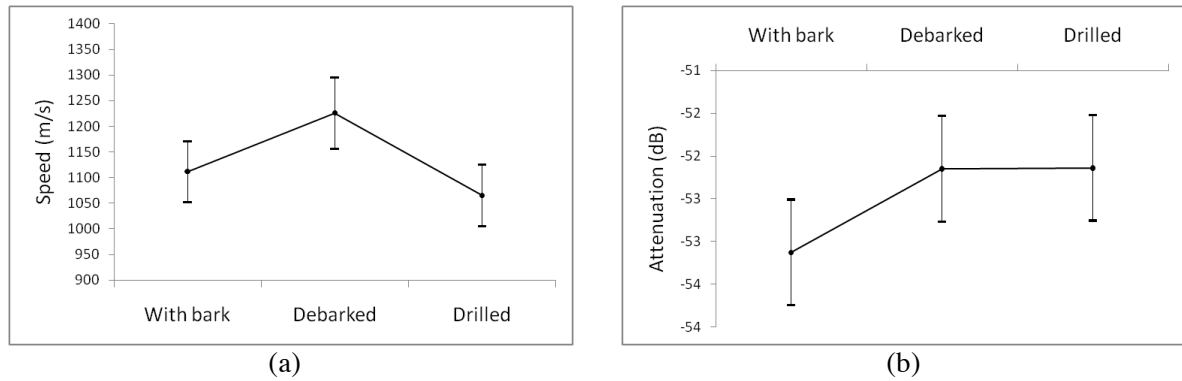
Figure 9. Means and standard deviations of speed (a) and attenuation (b) computed on 108 acquisitions for the disk with bark, debarked and drilled.

Mean comparisons were made to study the effect of bark and holes on the ultrasonic parameters (Figure 9). The number of acquisitions was 108 with an angular step of 30° . The statistical tests were firstly a Student's t-test on paired samples (Table 1).

The results of Table 1 were secondly completed by non-parametric Wilcoxon tests (valid when the normality assumption was not satisfied or the sample size was too small). The Wilcoxon tests agreed with those of Student's *t* for attenuation but did not confirm the Student's *t* results for speed (Table 1). The mean attenuation measured on the disk with bark was thus significantly different with the one after debarking. The mean attenuation was higher with bark than without bark. No significant difference was found between the mean attenuation of debarked disk and of drilled disk. Concerning the speed measurements, differences existed between disks with bark, debarked and drilled but the probability values were too high to be absolutely affirmative (Figure 9 and Table 1).

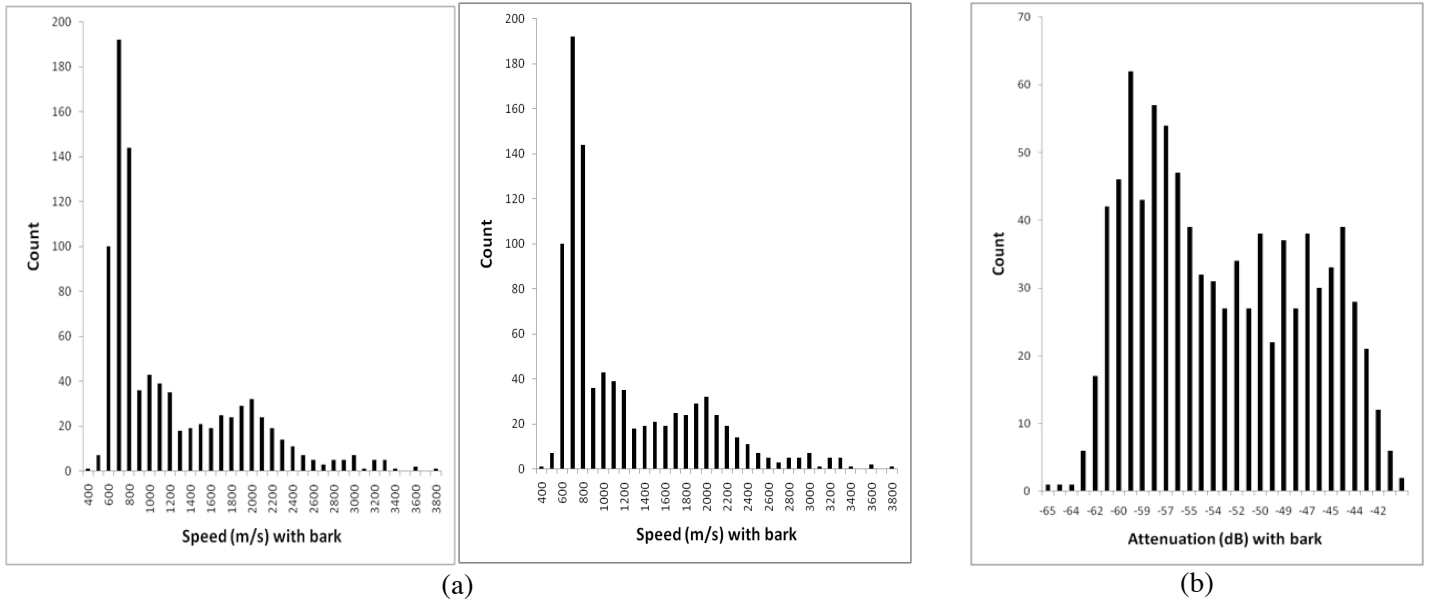
Figure 10. Histograms of speed (a) and attenuation (b) of acoustic waves at 55 kHz computed for the disk with bark (N=900).

The *t*-test results, presented in Table 1, were biased by the non normal distribution of the parameters. To highlight this phenomenon, two histograms were plotted (Figure 10) after the tomographic tests with an angular step of 10° (N=900). The bimodal distribution was shown on this figure for speed with two modes between 1200 (m/s). The same type of distribution was also observed concerning the attenuation between -51 (dB). Equivalent observations were made for the debarked and drilled disks.

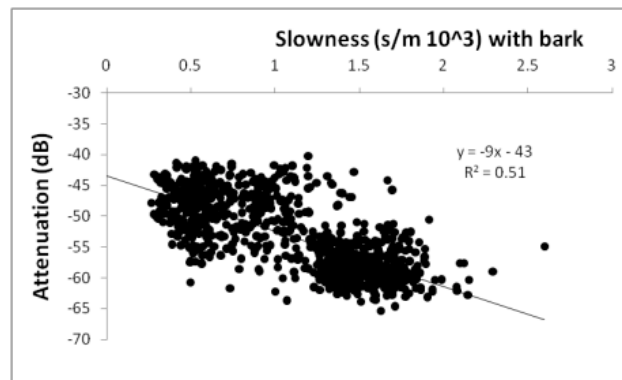
Figure 11. Relationship between slowness and attenuation for the disk with bark (N=900).

The Figure 11 showed a scatter plot between slowness and attenuation for the disk with bark. A significant linear relationship was found with a R^2 equal to 0.51 ($F=933$, $p < 0.001$, $N=900$). The attenuation increased when the slowness increased or the speed decreased. However, the degree of fit should be read with care because the Figure 11 clearly showed two populations (associated with the distributions of the Figure 10). Outliers were also visible due to the uncertainty on the slowness determination; but they were not associated to particular positions of the probes.

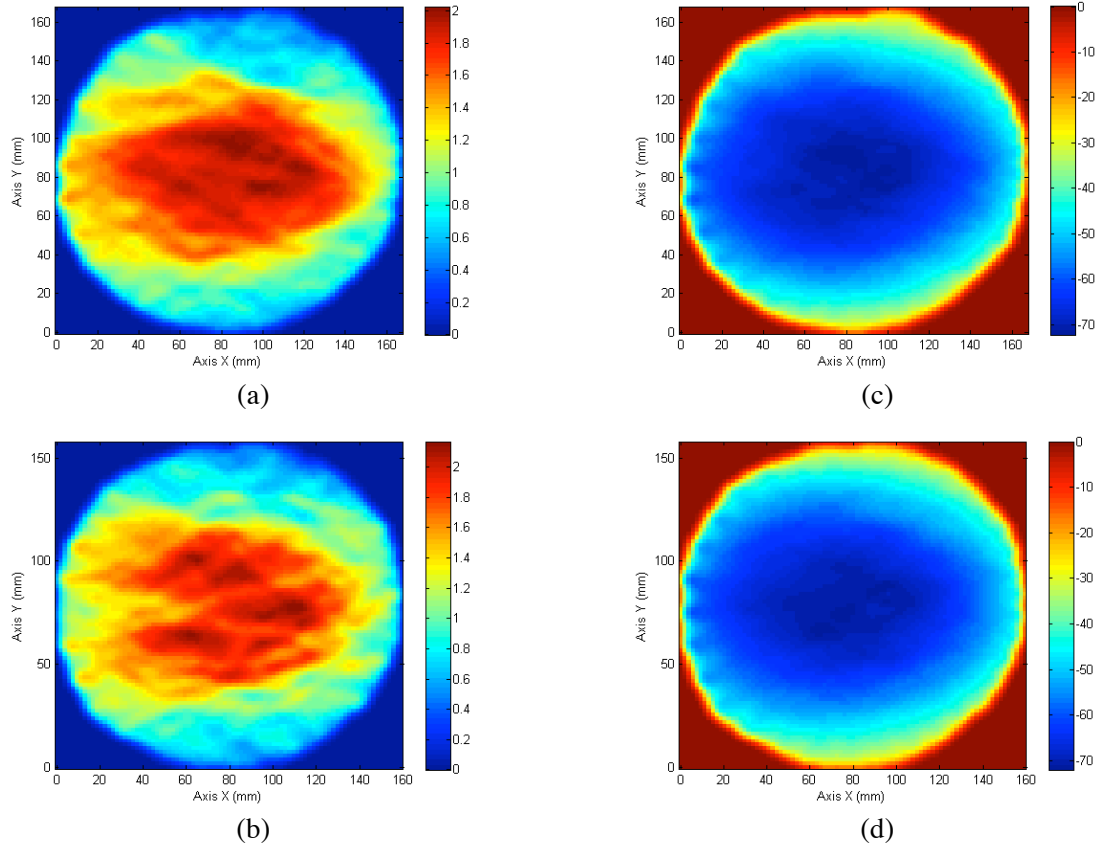
Figure 12. Tomographic maps of slowness (10^{-3} s/m) (a, b) and attenuation (dB) (c, d) for the disk of the first log, with bark (a, c) and debarked (b, d).

The computed maps of slowness and attenuation for the first log with and without the bark were presented at Figure 12. The images were displayed in 87x87 pixels and based on a 10° angular step (900 acquisitions). There was no visible effect of the presence of the bark on the outlines of the maps (Figure 12). This phenomenon was due to the low thickness of the bark (3 to 5 mm) compared to the wavelength (26 mm) added with the smoothing effect of the 2D filter.

The Figure 12 showed however two different areas from the pith to the periphery. These areas were highlighted at Figure 13 where the paths were drawn if the slowness was lower than 1.2×10^{-3} s/m and if the attenuation was upper than -51 dB. The periphery was thus characterized by a higher speed and a lower damping than the ones of the pith. The inverse phenomenon was observed by Socco and interpreted as an effect of the wood anisotropy [14]. The shorter paths (periphery) were more influenced by the tangential behavior of wood, while the radial behavior had a more important effect for longer paths (center). However, the radial velocity of wood is known to be upper than the tangential velocity. In this specific case (Figure 12), this observation was explained by the transition from juvenile to mature wood coupled with the effect of the moisture distribution (Figure 7).

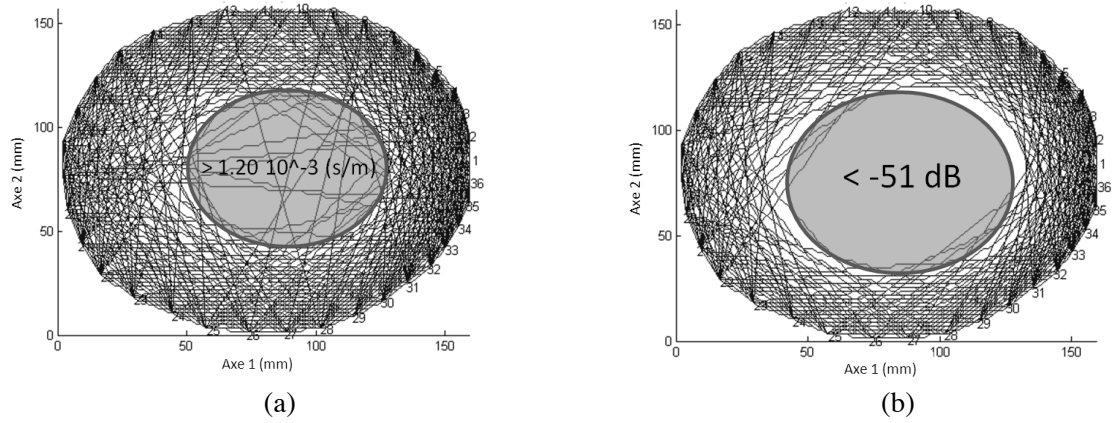
Figure 13. Paths of emitter to receiver with a slowness lower than 1.2×10^{-3} s/m (a) and an attenuation upper than -51 dB (b) for the disk of the first log with bark.

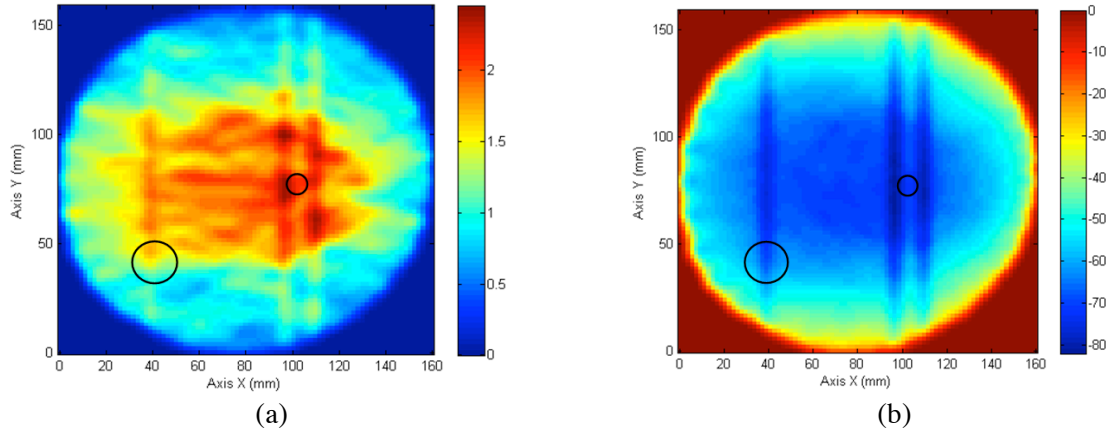
Figure 14. Tomographic maps of slowness (10^{-3} s/m) (a) and attenuation (dB) (b) for the drilled disk of the first log. The black circles indicate the positions of the drillings.

The tomographic images obtained for the drilled disks of the two logs were presented at Figure 14 and Figure 15. The effect of the holes was visible on the maps by areas with a high slowness and also a high damping. This observation was valid even for the hole which diameter (10 mm) was the half of the wavelength (26 mm). It seemed that the position of holes in the disk had an effect on the reconstructed pattern; the holes closed to the pith were characterized by two elliptic patterns at the difference of those closed to the periphery. The shape of the patterns associated with the holes was not a circle but an ellipse and several hypotheses were advanced: the anisotropy was not taken into account, some cracks due to natural drying occurred, the reconstruction procedure was not well adapted for missing data (the dimension of the probe supports not allowed to scan the total angular area but only 250° for each projection), the mounting of the probes (Figure 5, right image) induced back waves which altered the received signals. These hypotheses will be investigated in a future study to improve the tomographic process.

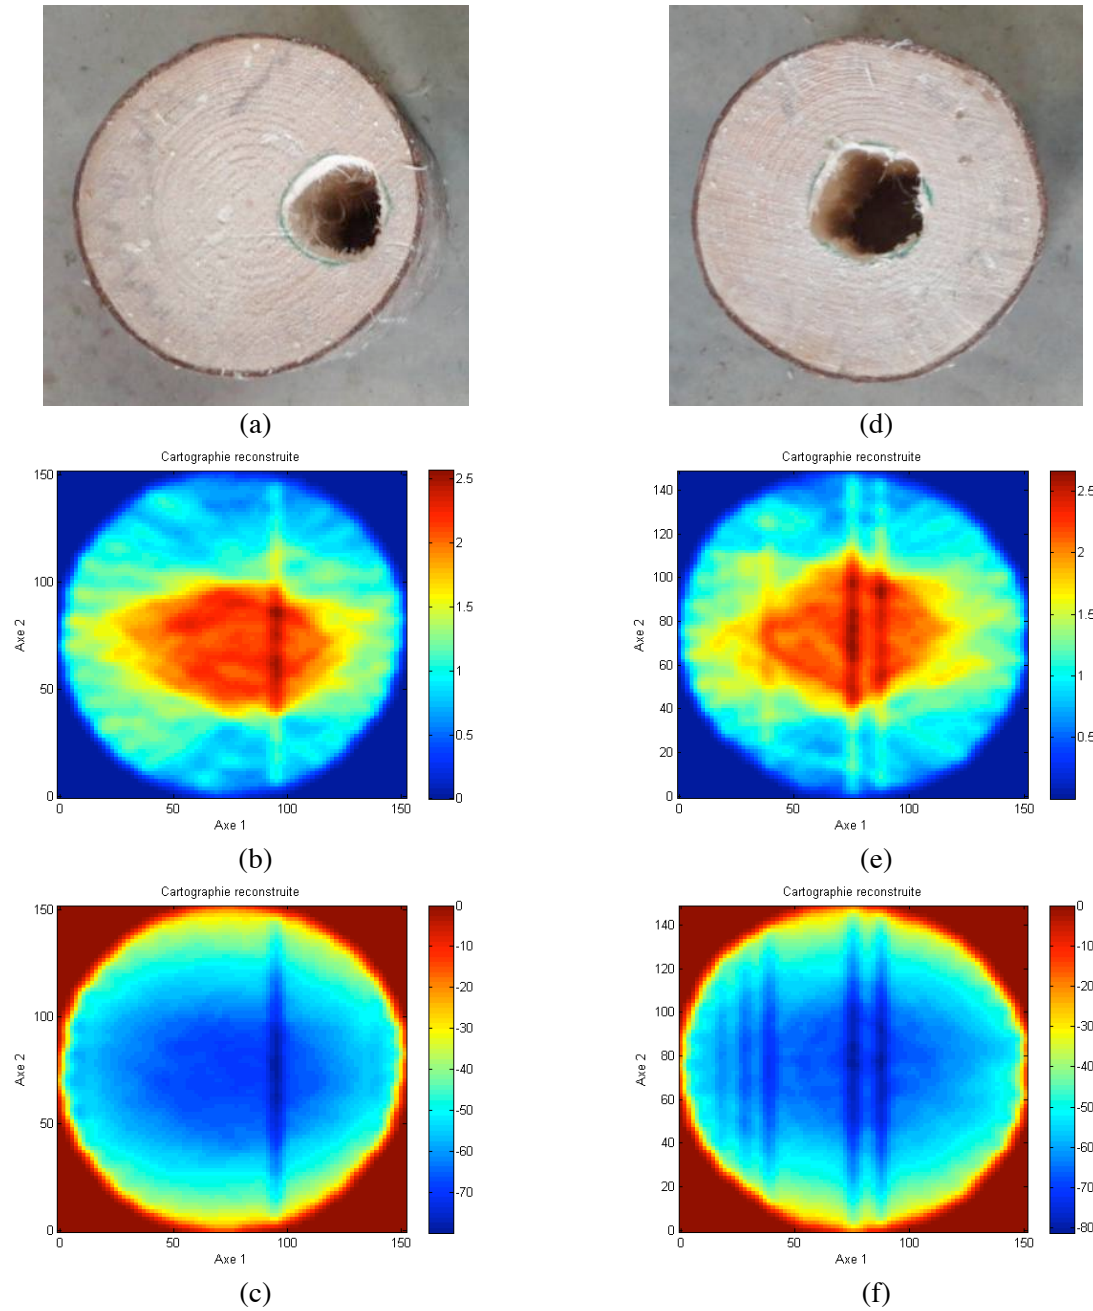
Figure 15. Tomographic maps of slowness (10^{-3} s/m) (b, e) and attenuation (dB) (c, f) for the two disks of the second log (a, b).
